TOWN OF SWAN RIVER

# SWAN RIVER CENTENNIAL ARENA ASSESSMENT AND RECOMMENDATIONS

October 30, 2018

PROJECT NO.: 181-10207-00  
DATE: OCTOBER 30, 2018

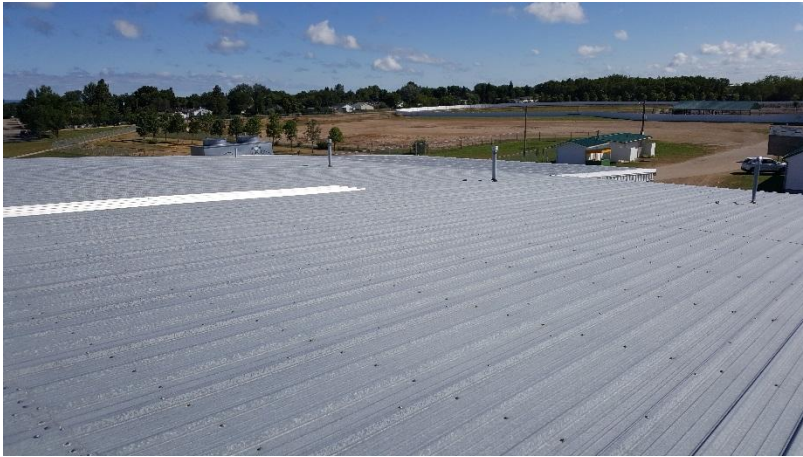
Photo 1: Main Arena Roof (1967)

The roof of the original Arena building is surface-fastened sheet metal with visible areas of rusting. As noted in client supplied documentation, the roof was replaced in approximately 1998. The roof is maintained on an ongoing basis by arena staff. Repairs should include the periodic checking, tightening and/or replacement of the gasketed screws for tightness and sealing, replacement of brittle and cracked gaskets and joint sealant, and resealing around exhaust fans and vent stacks in the short term (Priority 1). It is our understanding that the management of roof leaks is being funded by Annual Operating and Maintenance funds and as such we have not allocated dollars in our Capital Expenditures Projections table.

Based on the current age of the main Arena roof (estimated at 20 years) a replacement of the entire roof system should be anticipated near the end of the report term period. (allocated in Priority 3).

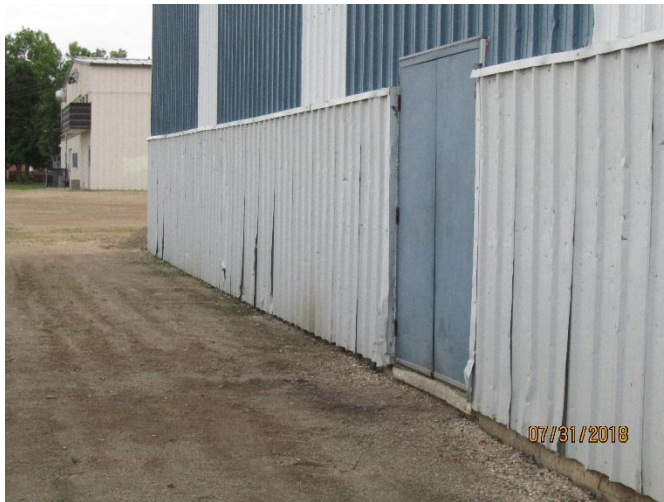
Photo 2: Exterior Cladding

A significant replacement of the existing exterior cladding was completed in 1997. Areas of damage (puck and vehicle strike damage, penetrations and rusting) to the lower half of the cladding was noted on all elevations. Repairs to the exterior cladding would include a replacement of the lower sections (approximately 10'-0") and should be allocated for as a Priority 2.

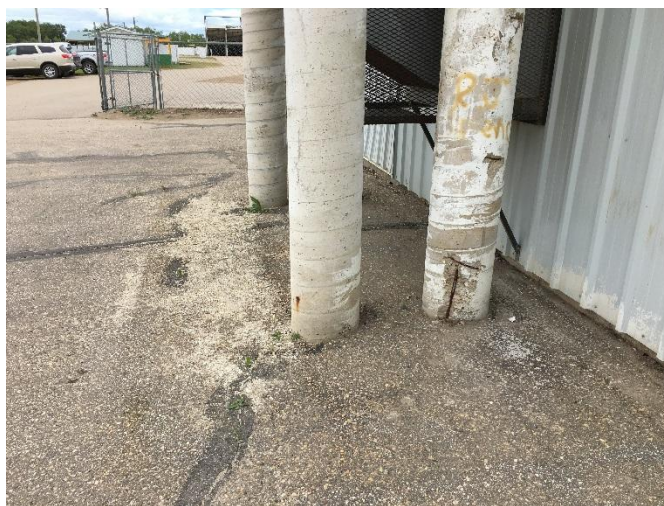
Photo 3: Outdoor Condenser Platform Support Piles

The ice plant condenser unit platform located on the north side of the building exterior is of steel construction mounted on four concrete piles above grade. Access to the platform is obtained by use of an extension ladder. The current platform is protected by a perimeter tubular metal guardrail that does not appear to conform with the building code. (Reference 4.1.5.14 [National Building Code] Loads on Guard and Handrails). The guardrail support posts currently rest only on the grating and not on the horizontal channel rails. The platform framing appears to be inadequate for structural loading. Refer to 3.1.3 for Additional Recommended Studies and Assessments.

- Piles have rebar and ties showing with significant corrosion. Requires repairs and patching.
- Support framing of the platform should be confirmed and upgraded if required.
- Mechanical Equipment Platform repairs would include a new steel platform structure with code compliant guardrail system.

Replacement of this guardrail is recommended to be completed as a Priority 1

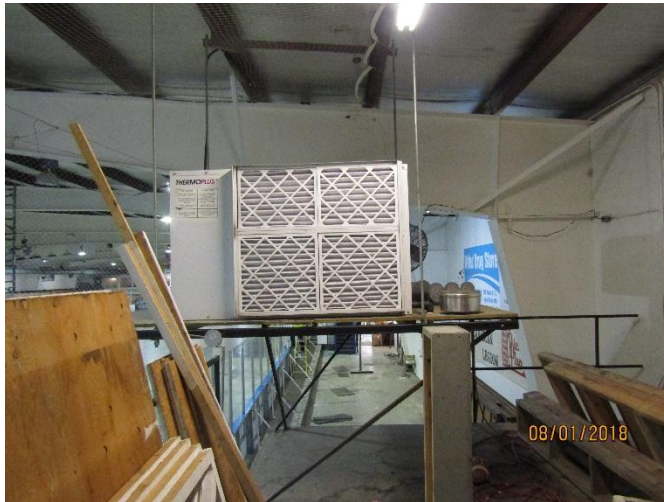
Photo 4: Indoor Dehumidifier Platform

The dehumidifier unit platform located on the south side of the ice rink interior is of plywood and steel construction supported from the ceiling structure above a storage room. Access to the platform is obtained by use of a set of open wood stair risers to the roof of the storage room, no structure is provided to access the actual suspended platform. The platform is currently not protected by a perimeter guardrail. This arrangement poses a potential safety risk to personnel accessing and servicing equipment. Consideration should be given to the installation of a “restricted access” chain or lock to prevent unauthorized public access.

Replacement of the platform complete with safety guardrail is recommended to be completed as a Priority 1 at the same time as the replacement of the Rink Dehumidifier unit.

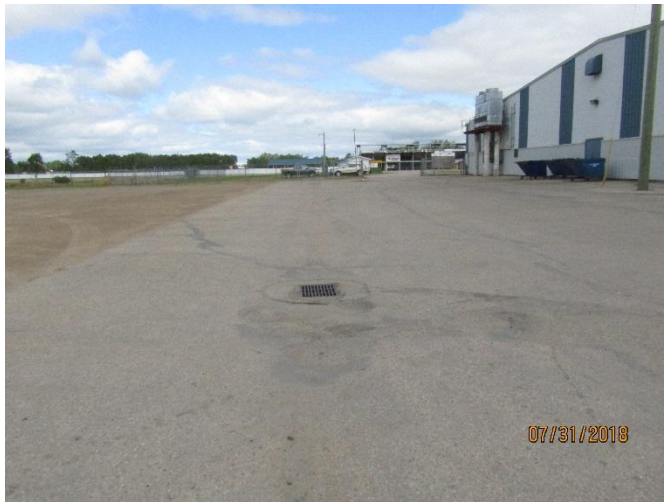
Photo 5: General Site Grading around Building

Currently the south elevations of the original Arena building and the 1973 addition appear to not have consistent positive drainage away from the foundation wall. This appears to have resulted in damage to the south arena wall as well as allow water infiltration into the crawlspace area under the 1973 addition.

Regrading for positive drainage around the perimeter of the south side of the Arena and all sides of the 1973 addition is required to reduce water infiltration into these systems.

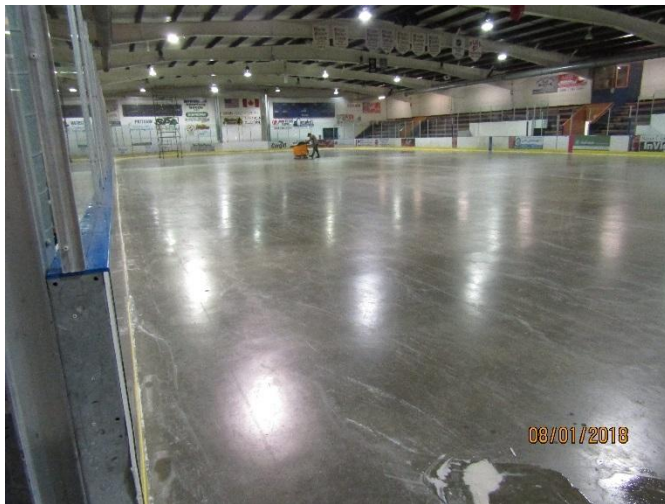
Photo 7: Arena Slab

- Arena slab floor is heaving. Measured from 2-3" over 15ft. Heave was generally centered in the middle section of the rink with the largest movement observed on the south west side of the slab. The slab movement in this location was up 3", 15-20 feet from the boards.

- Arena Slab Repair/Replacement would generally include removal of the rink and ring slabs, complete excavation of all frozen sub base material under the arena slab. This would be replaced with compacted fill and a new rink slab and apron slab floor system.

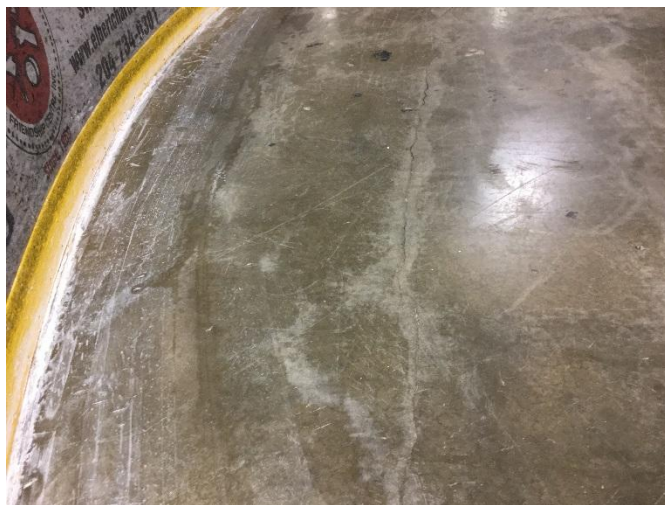
Photo 8: Arena Slab - cracks

- Cracks are visible along the edges parallel to the side of the rink, usually 4 rows 36" OC.
- Slab movement was noted to be gradual as reported by client and site personnel.

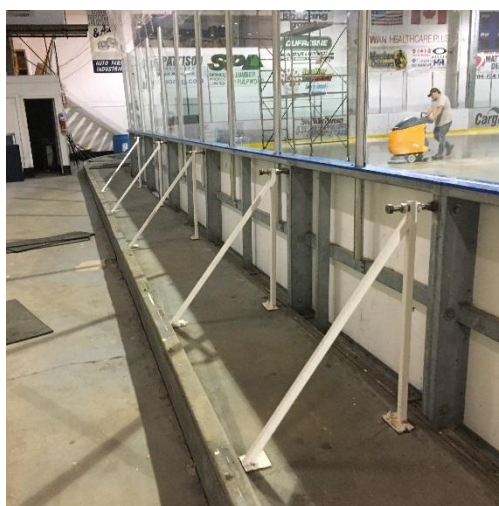
Photo 9: Arena Ring Slab

- A 34" ring beam at the sides of the rink is shifting causing issues with the stands
- Worse along the west edge
- Slab is shifting up and crushing plywood along the connection of the bleachers seating and arena boards.
- Remaining foundation of the stadium seating (where visible) does not show any indications of slab movement. However, there is no access for visual assessment to much of the slab below the seating area.
- Concrete is cracking near the added elevated seating on the east side.
- Arena Ring Slab Replacement would be integrated into the Rink slab replacement design.

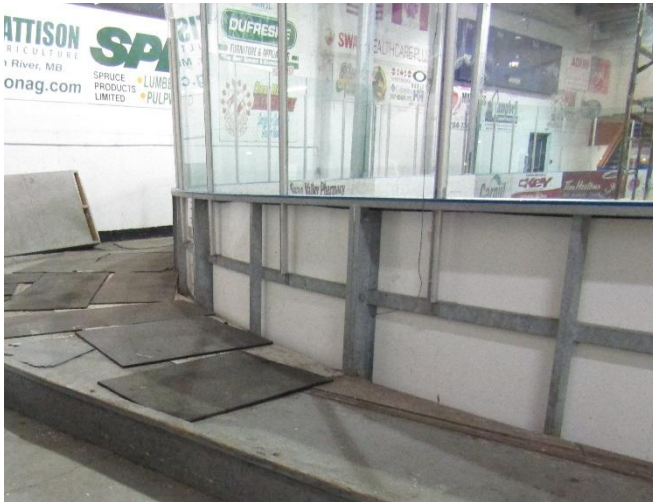
Photo 10: Boards

The rink dasher board system (boards and glass) is in reasonable condition but have been modified in terms of alignment to suit the changing conditions due to the concrete slab concerns. With the replacement allocation of the rink slab it is reasonable to replace the rink dasher board system at the same time. (Priority 1)

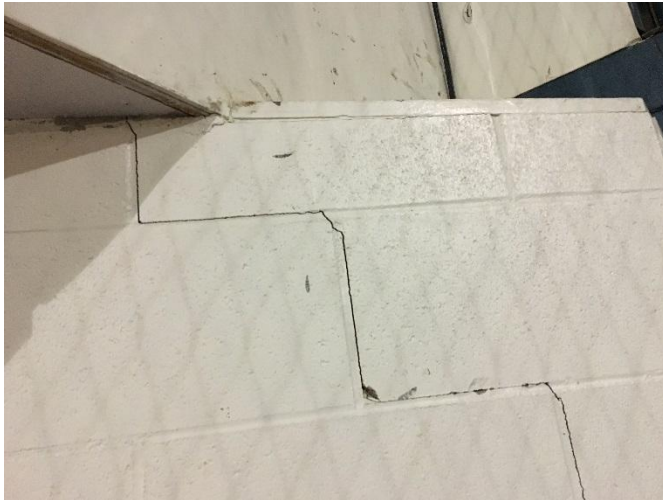
Photo 11: Concrete Block Crack

- Cracked block wall on North West side of arena near the access door appears to have been caused by some movement in the wall. The crack runs through the masonry block units and requires more investigation to determine cause and severity. This is a former main building exterior wall – and is load bearing, therefore the repairs should be given a level 2 priority.

The cracked block wall on west side of arena requires further inspection to determine the cause of the damage and if any repairs would be required.

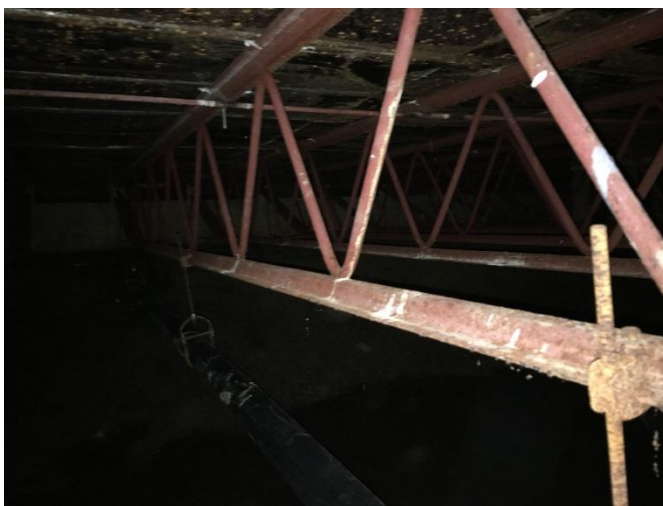
Photo 12: 1973 Addition Crawlspace – Joists and Deck

Water found in crawl space – concrete floor

High water levels in previous years filling the crawl space and needing to be pumped out was reported by client. Moisture Control, Sump pump, air exhaust and supply required to maintain humidity in space

Deck and joists show visible surface rust and developing areas of corrosion

Crawlspace Deck and Joists repair would include upgrades to the crawl space to repair the water infiltration and a detailed inspection of the crawlspace are to confirm the extent of the joist and decking corrosion.

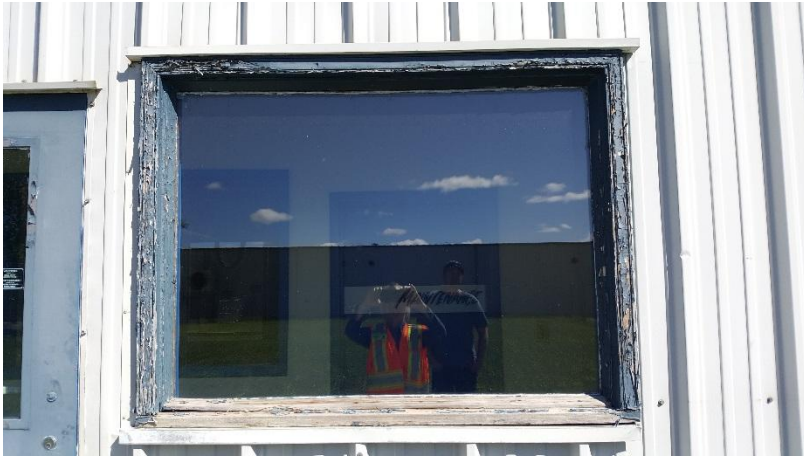
Photo 13: Windows

The exterior windows throughout the building are of various types (wood framed, PVC framed, etc.) and vintages. Caulking and seals are in poor condition and signs of leaking were observed in some locations.

Scheduled replacements to the window are suggested.

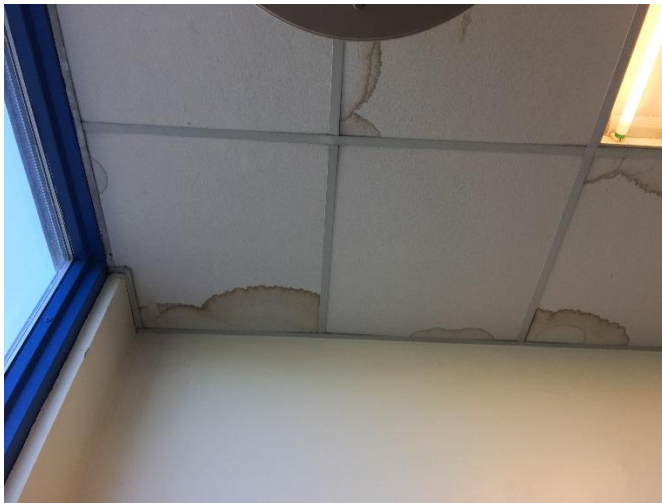
Photo 14: Roof Leak Repairs

The 1968 addition requires leak repairs in the short term as part of ongoing maintenance. Repairs should include screw fastener checking, the replacement of brittle and cracked gaskets and joint sealant, and reseal around the roof openings in the short term (Priority 1).

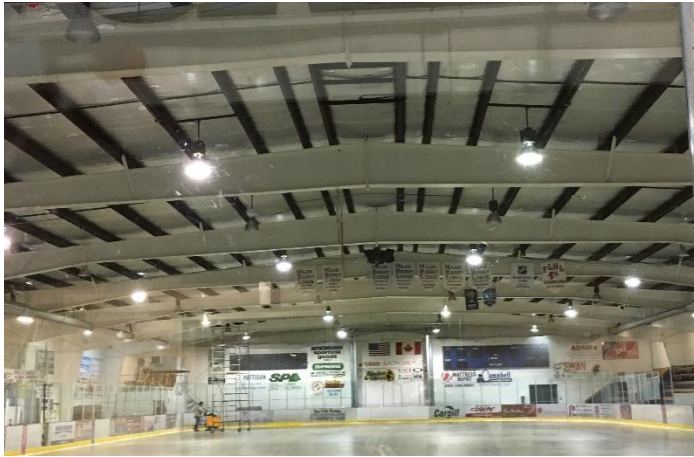
Photo 16: Pre-Engineered Roof Support System – Purlins

- Purlins have developed surface rust. This may develop section loss if not remediated periodically. Efforts to clean and paint these members has been initiated and should continue on an annual basis in order to extend the life of the material.

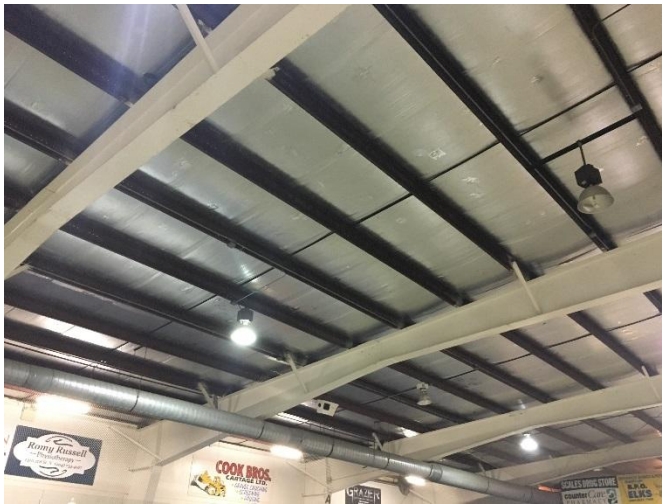
Photo 17: Pre-Engineered Roof Support System – Roof Cross Bracing

- Roof cross-bracing lines are in a similar state to the described purlin conditions and should be cleaned and painted to limit the corrosion process. Similar to the wall bracing, roof cross braces should be tightened to ensure an efficient load transfer to the buildings bracing system.

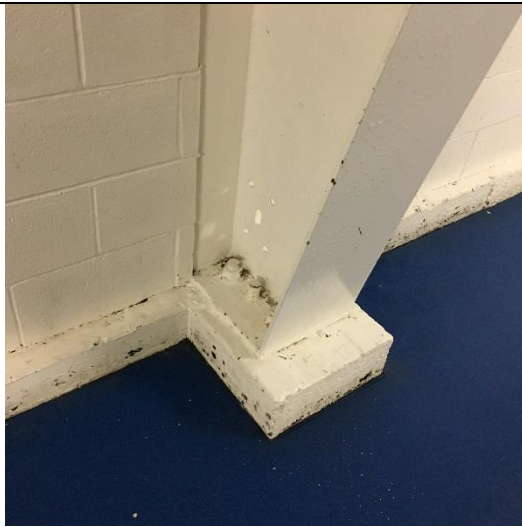
Photo 19: Missing Anchor Bolt Nut

- Missing anchor bolt nut along west side should be replaced by Arena maintenance staff.

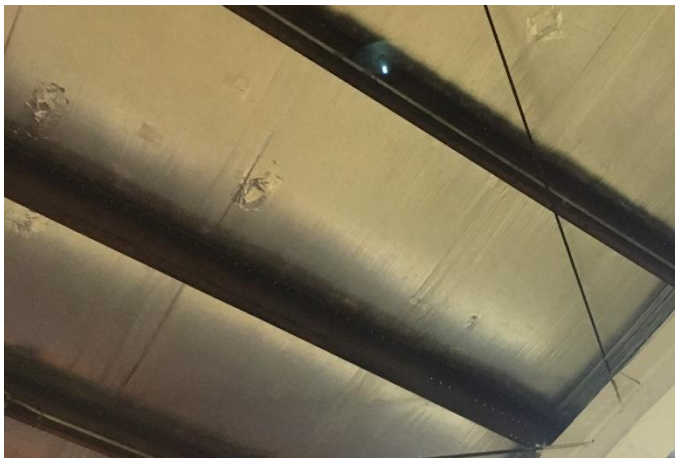
Photo 21: Ceiling Reflective Surface

The foil backed insulation that serves as a reflective blanket on the underside of the roofing system shows some evidence of deterioration and previous repairs. Consideration should be given to extending the protective netting to the underside of the ceiling to help mitigate future damage. It is our understanding that the management of these repairs is being funded by Annual Operating and Maintenance funds and is not allocated dollars in our Capital Expenditures Projections table.

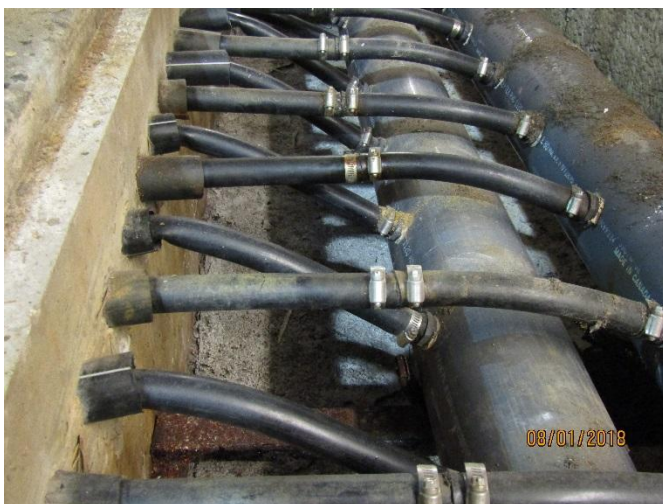
Photo 24: Brine Piping Loops in Header Trench

The Client reported that there have been several under slab leaks occurring. CIMCO has been consulted periodically. Leaks reported under slab as recently as early September 2018. This item is considered as an ongoing Priority 1 but is currently managed within the annual operating and maintenance funding. We have included in our opinion of probable cost form an allowance for new brine piping system as part of the new rink slab installation.
